# Vegetation Status in Waituna Lagoon: Summer 2022

This report was commissioned by The Department of Conservation (DOC) and based on work under Project DOC20203.

DOC commissioned NIWA to undertake the 2022 summer-time Waituna Lagoon survey to document the health of submerged vegetation and to provide an inter-annual comparison of its condition. This report summarises the key findings to guide further ecological management of the lagoon.

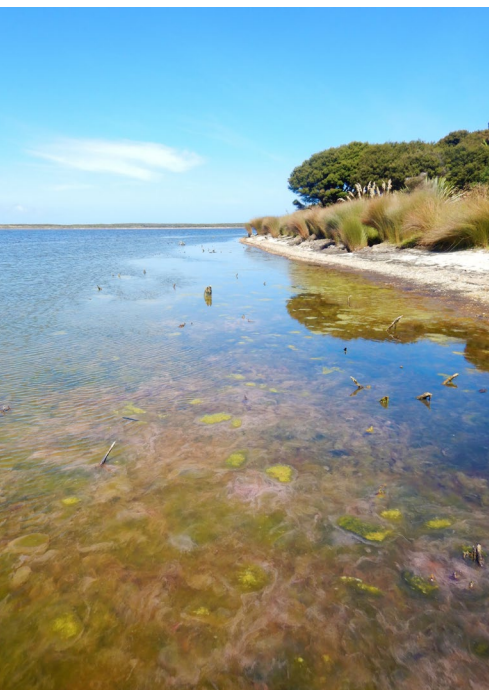
Figure 1: *Ruppia* vegetation can safeguard water quality in the lagoon compared to a system with no plants.

Submerged plants have an important role in keeping shallow lakes and lagoons clean and healthy (Figure 1). If submerged plant communities become too stressed, they can collapse. The lake or lagoon then enters a new, dirty water state, with high levels of resuspended sediment and development of macroalgal mats or phytoplankton blooms instead of plants. The submerged native plant species of *Ruppia* (horse's mane) safeguard water quality in Waituna Lagoon. *Ruppia* tolerates fluctuating levels of saltwater in lagoons better than other submerged plants, but does not occur in the sea. Other plants, including a nationally rare, salinity-tolerant charophyte, also occur at Waituna Lagoon.

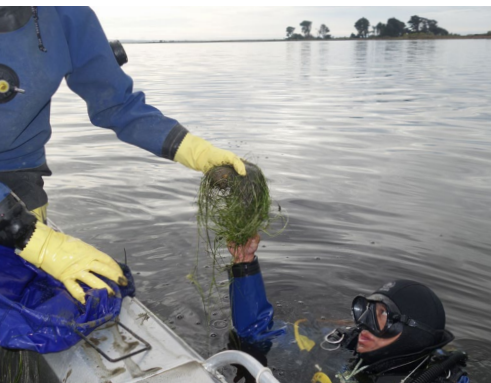
Figure 5: Lagoon-wide cover of *Ruppia* is shown as green bars and percentage of sites at which *Ruppia* was present as a blue line.

Lagoon-wide average cover in 2022 did not meet the ecological target (Box 1) of >30–60% (Table 2, Figure 5). However, all *Ruppia* measurements for 2022 (Table 2) showed substantial increases compared with the previous two years when the lagoon closure target was not met (Table 1).

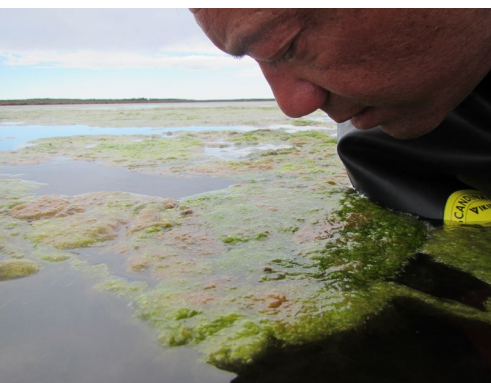
Figure 6: Lagoon-wide cover of macroalgae is shown as orange bars and percentage of sites at which macroalgae was present as a blue line.

Nutrient enrichment of waterbodies may result in excessive macroalgae growth that smothers the lake bed and shades *Ruppia* plants. One ecological target (Box 1) recognises that macroalgae on the lagoon bed (benthic), on plants (epiphytic) and floating mats should be no more than minor (<10% cover). In 2022, the lagoon-wide average macroalgae cover substantially exceeded the 10% cover limit and was the second highest value recorded (Table 4 and Figure 6). This result continues a general trend of greater macroalgal growth for years since 2015, (Table 4 and Figure 6) regardless of whether the lagoon closure target was not met (Table 1).
