Vegetation Status in Waituna Lagoon: Summer 2024

This report was commissioned by The Department of Conservation (DOC) and based on work under Project DOC24203.

DOC commissioned NIWA to undertake the 2024 summertime Waituna Lagoon survey to document the health of submerged vegetation and to provide an inter-annual comparison of its condition. This report summarises the key findings to guide further ecological management of the lagoon.

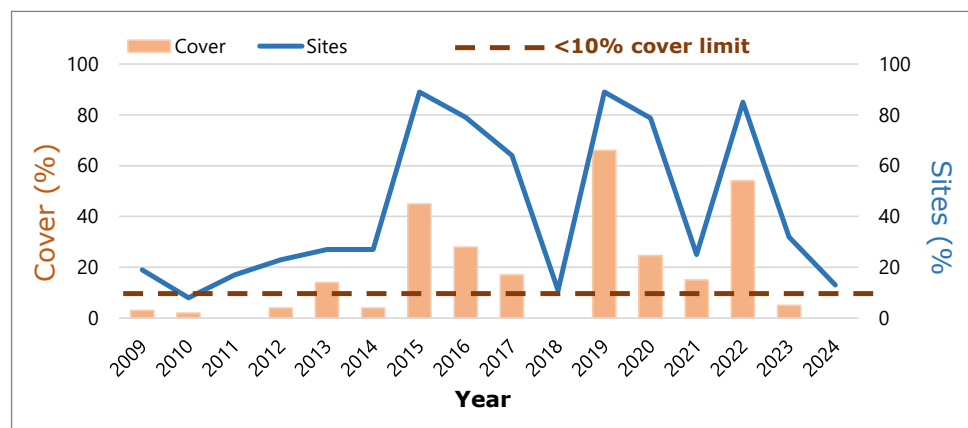
Figure 6: Lagoon-wide cover of macroalgae is shown as orange bars and percentage of sites at which macroalgae was present as a blue line.

In 2024, the target for macroalgae cover was met (Table 4) and this year was one of the lowest values yet recorded. It is the second year in a row the target has been met, following four years (2019–2022) of high summer macroalgal development (Table 4, Figure 6). There is no pattern of high or low macroalgal development with the status of the lagoon closure target (Table 1).
